OFFICIAL STEERING & SUSPENSION OF NASCAR®

## DID YOU KNOW?

On the affected vehicles, improper installation of a new hub assembly may cause an ABS, cruise control and/or VDC (Vehicle Dynamics Control) fault code to occur.

SUBARU	Legacy Outback	2005-2014
--------	-------------------	-----------

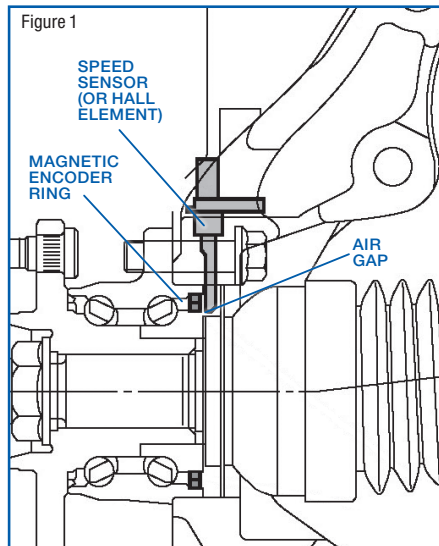
Figure 1

Check for rust. Any rust present on the mounting area or on the backing plate can keep the bearing assembly from being fully seated (even when torqued down), creating an excessive "air gap" between the encoder and the sensor. It only takes a few extra thousandths of an inch to trigger the false error codes. (Fig. 1)

In addition, during re-assembly any rust present on the knuckle or backing plate may be dislodged, and will adhere to the magnetic encoder ring of the new hub assembly. Also, check for any dirt, grease or metal particles on the tip of the sensor. Any of these conditions will cause interference within the magnetic field and will result in the pulse being erratic or blocked altogether.

Note: It's imperative  
to remove loose  
rust to prevent an  
excessive air gap.
